# Cycle Path Condition Monitoring Techniques

Chase Fleeman, Michael Nieminen (ICC, Florida, USA)

ERPUG 2023

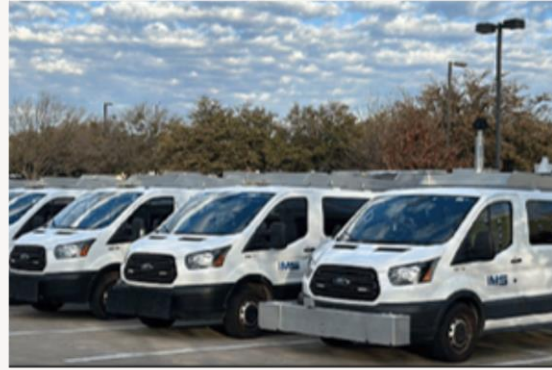
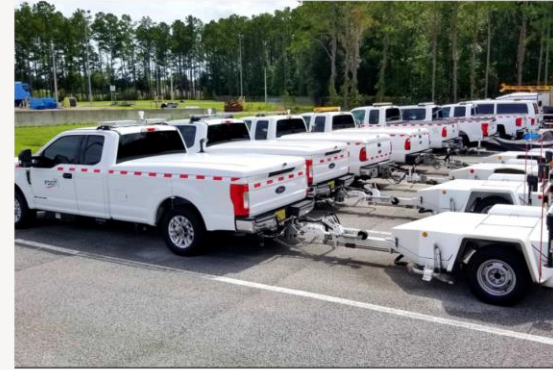
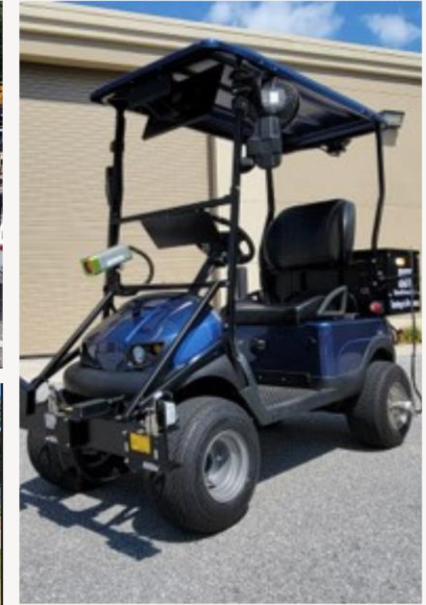
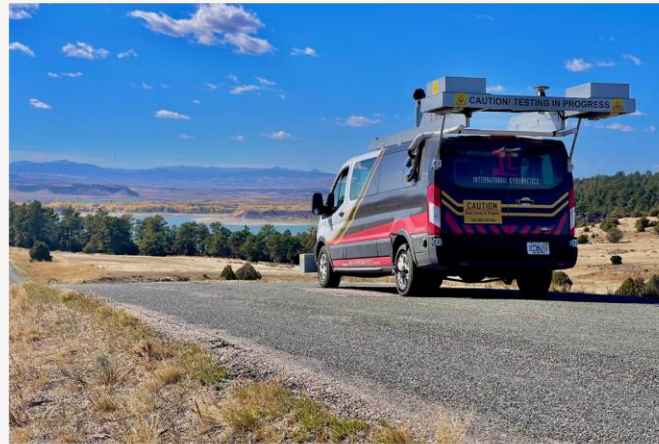
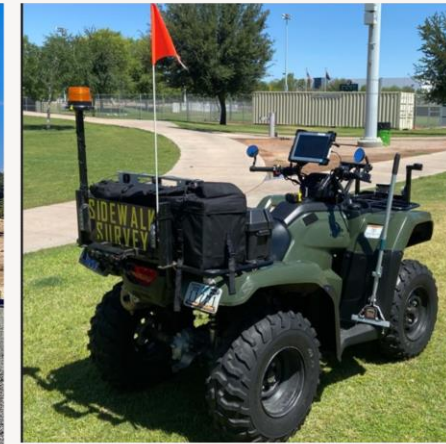
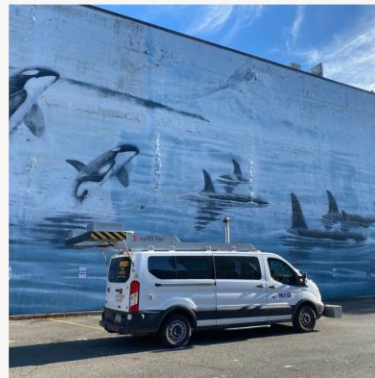
# Sidewalk Surface Tester (SST)

- Introducing the new SST for sidewalk and trail surveys
- Platform testing and selection
- Designed and built in 2023
- Based on same Drive platform as ICC's Iris family of collection vehicles

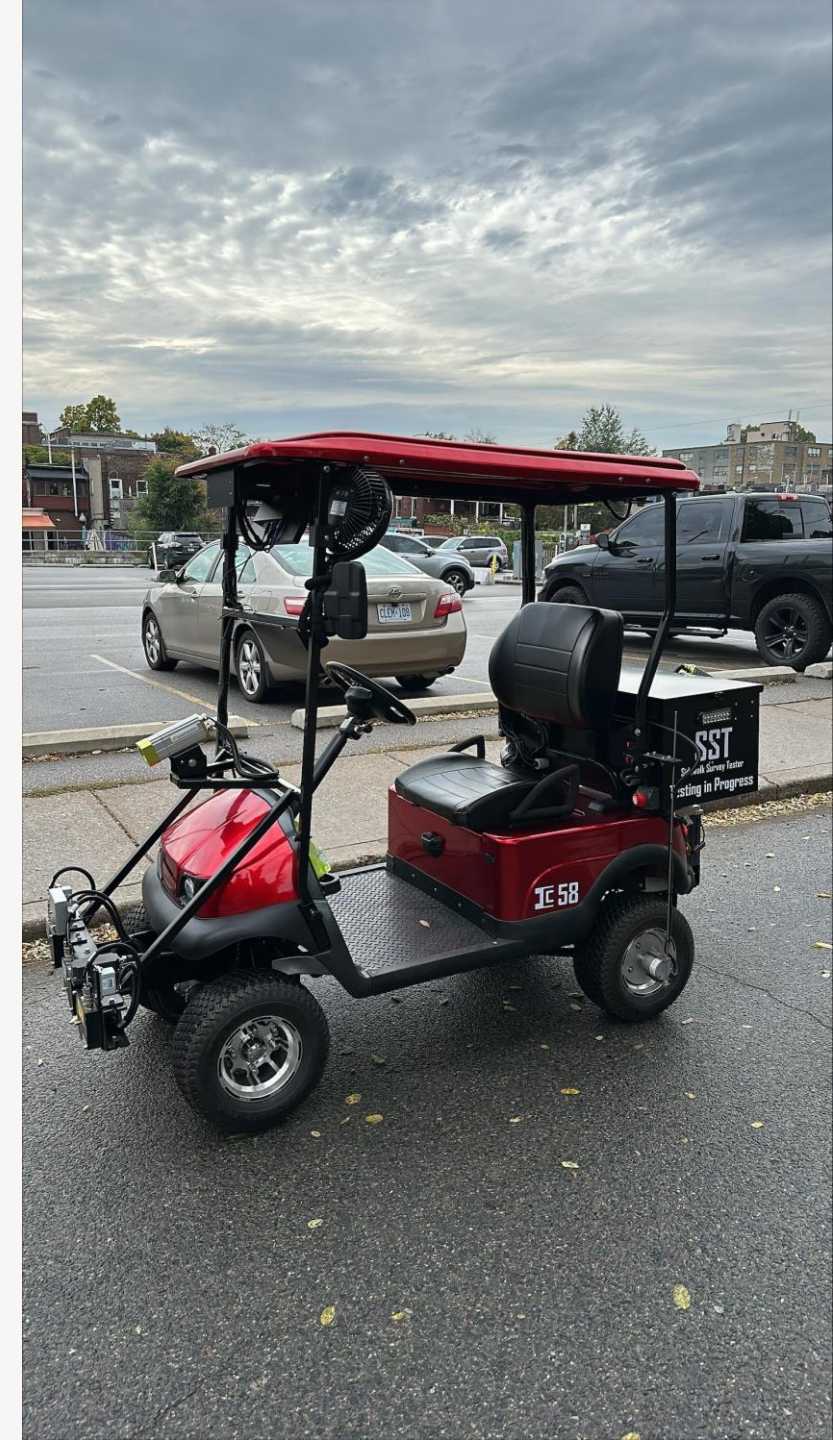
# Subsystems

- 3x Gocator point lasers
- 2x 12MP Basler cameras (front and rear)
- 5g Accelerometers
- 250 Hz MEMS IMU
- Hemisphere DGPS
- 5,000 CPR wheel encoder
- Target sensor
- Drive collection system (fanless computer and ADAS in environmentally-sealed enclosure)
- High contrast monitor
- Event keyboard

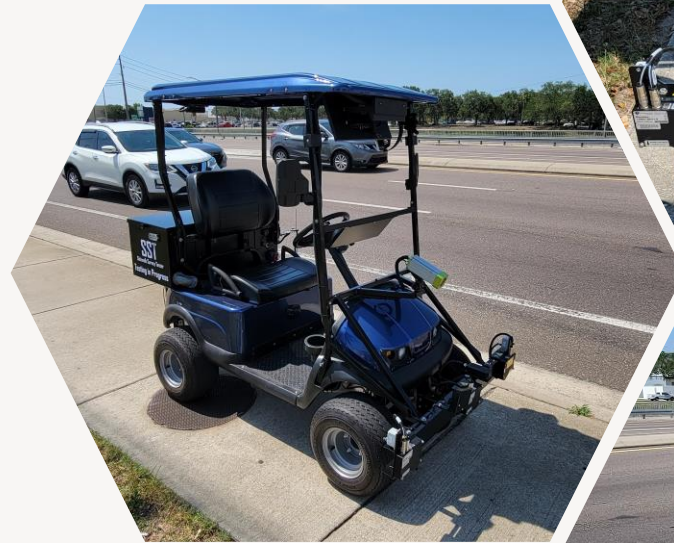
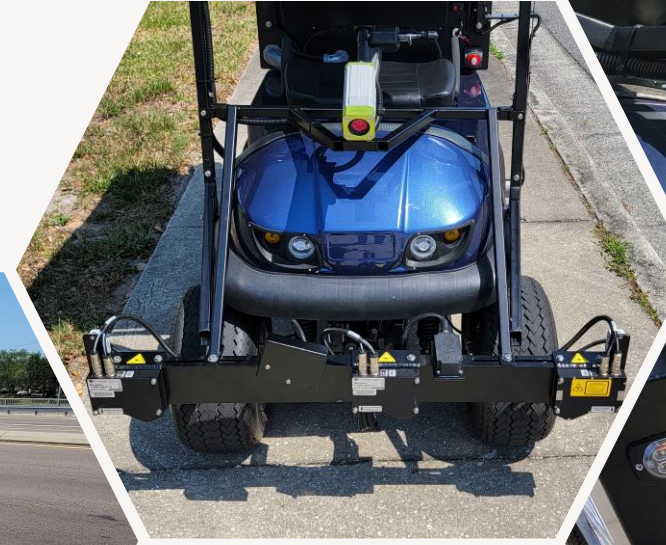
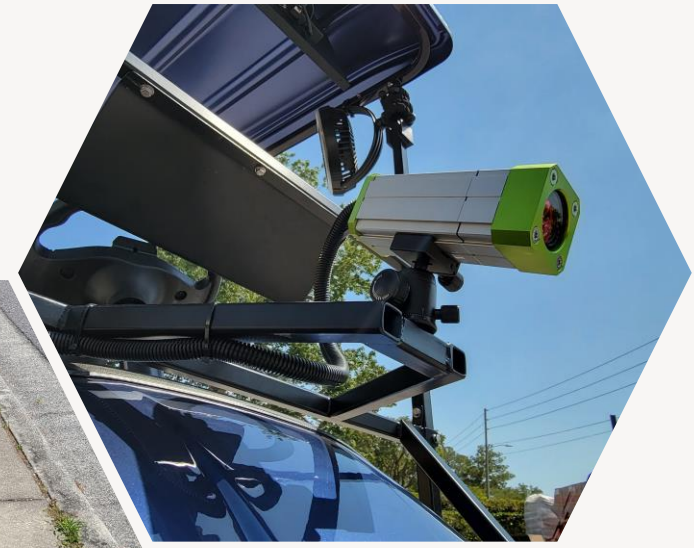
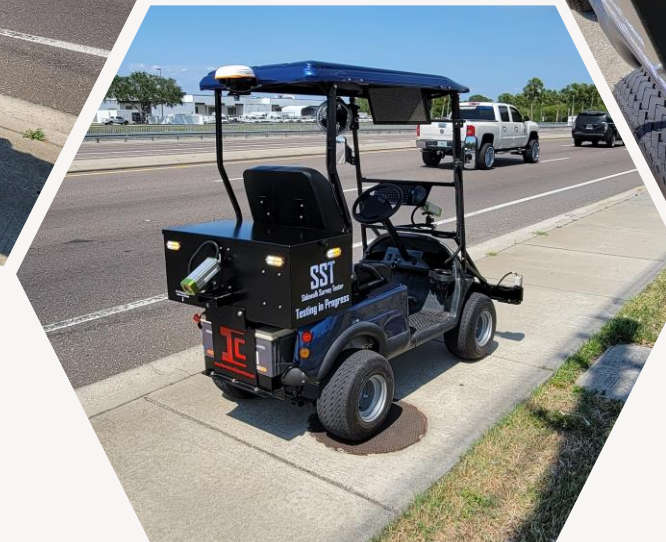
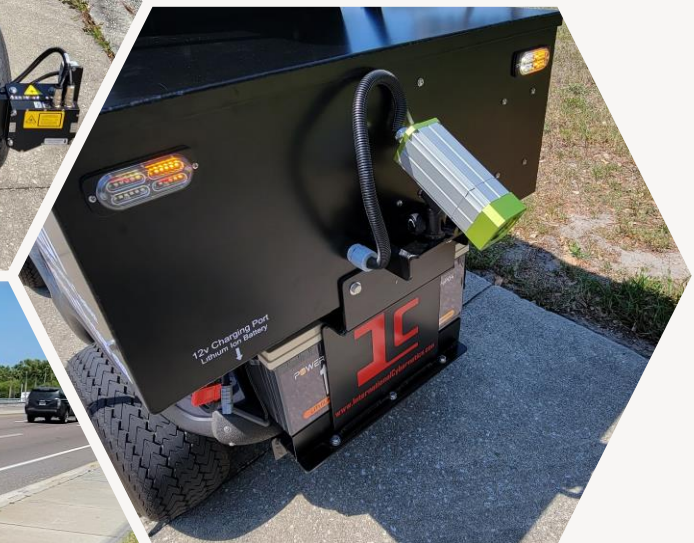
# Measurements

- Front and rear right-of-way images at 1.5 m intervals (captured at fixed interval)
- Laser Elevations at 0.5 or 1.0 m longitudinal spacing (captured at fixed interval)
- Pitch, Heading, and Roll at 250 Hz
- All data synchronized to DMI and GPS to 0.0001 s (0.1 ms)

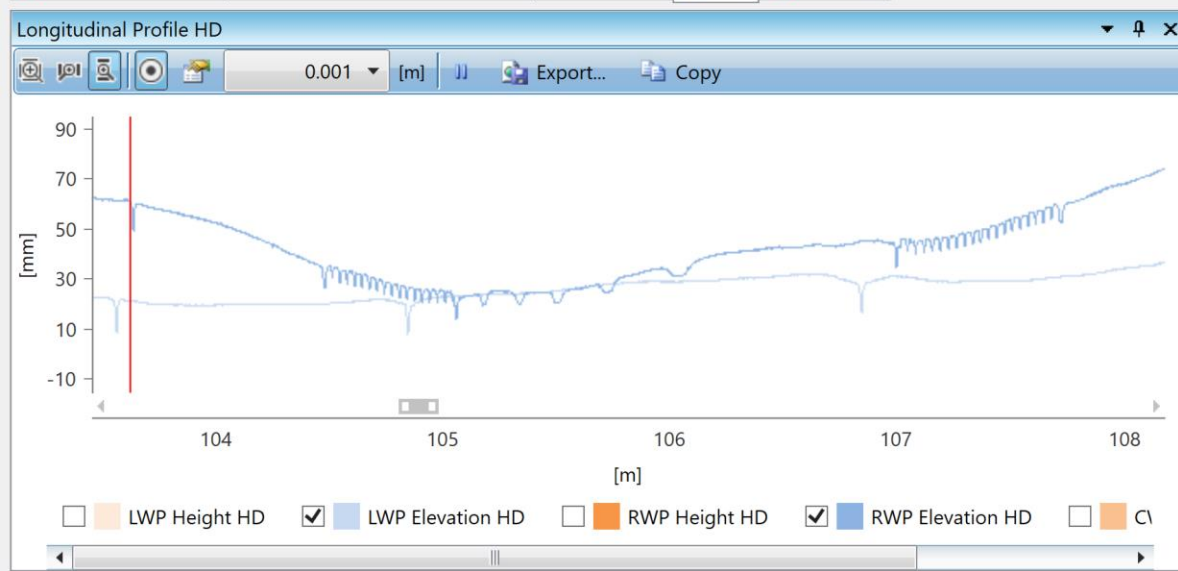
# HD Profile shows Joints and Texture

Longitudinal Profile Detected Obstacles and Gaps Collections Map Geometry

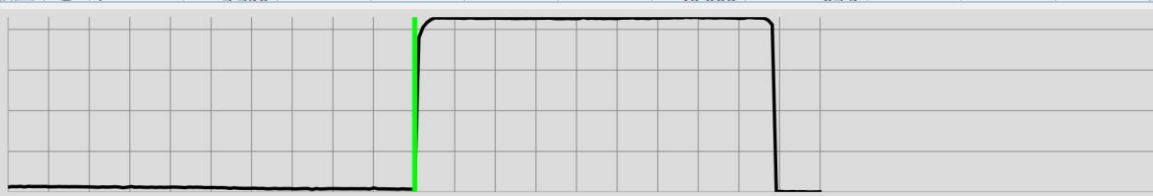
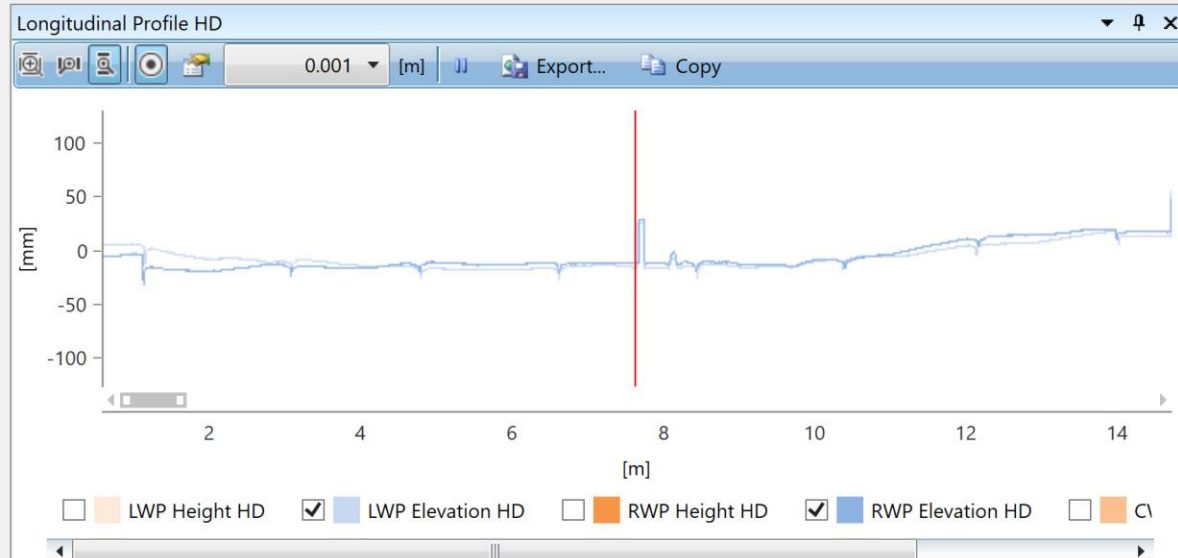
# Obstacle and Tripping Hazard Detection

Locat	Start [m]	End	Lengt [mm]	Depth	Width	Heigh	Rise/Fall Angle [°]	Distre	Sever	Items
<input type="checkbox"/>	R	1.120					-16.297	83.0			
<input checked="" type="checkbox"/>	L	7.641					41.981	87.1			
<input type="checkbox"/>	R	7.652					41.311	87.1

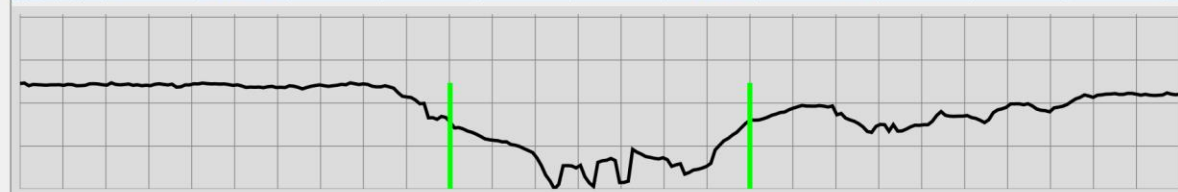
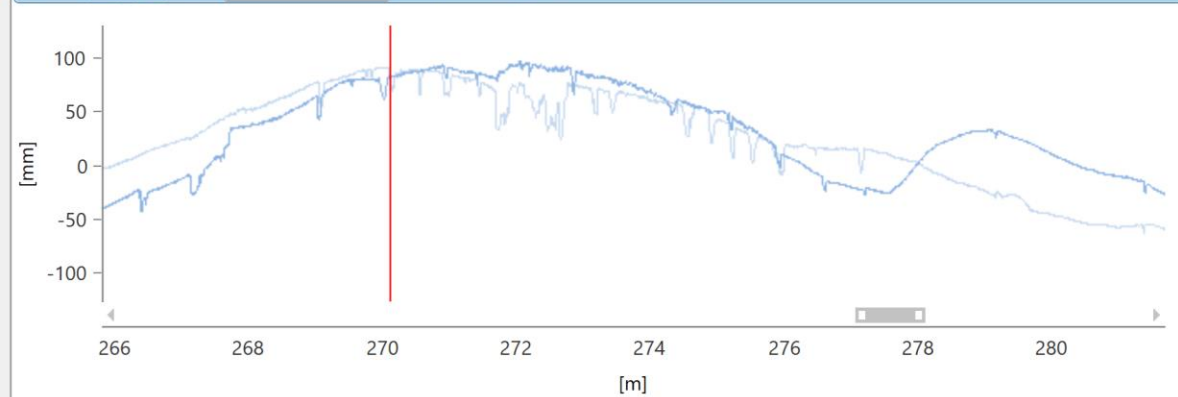
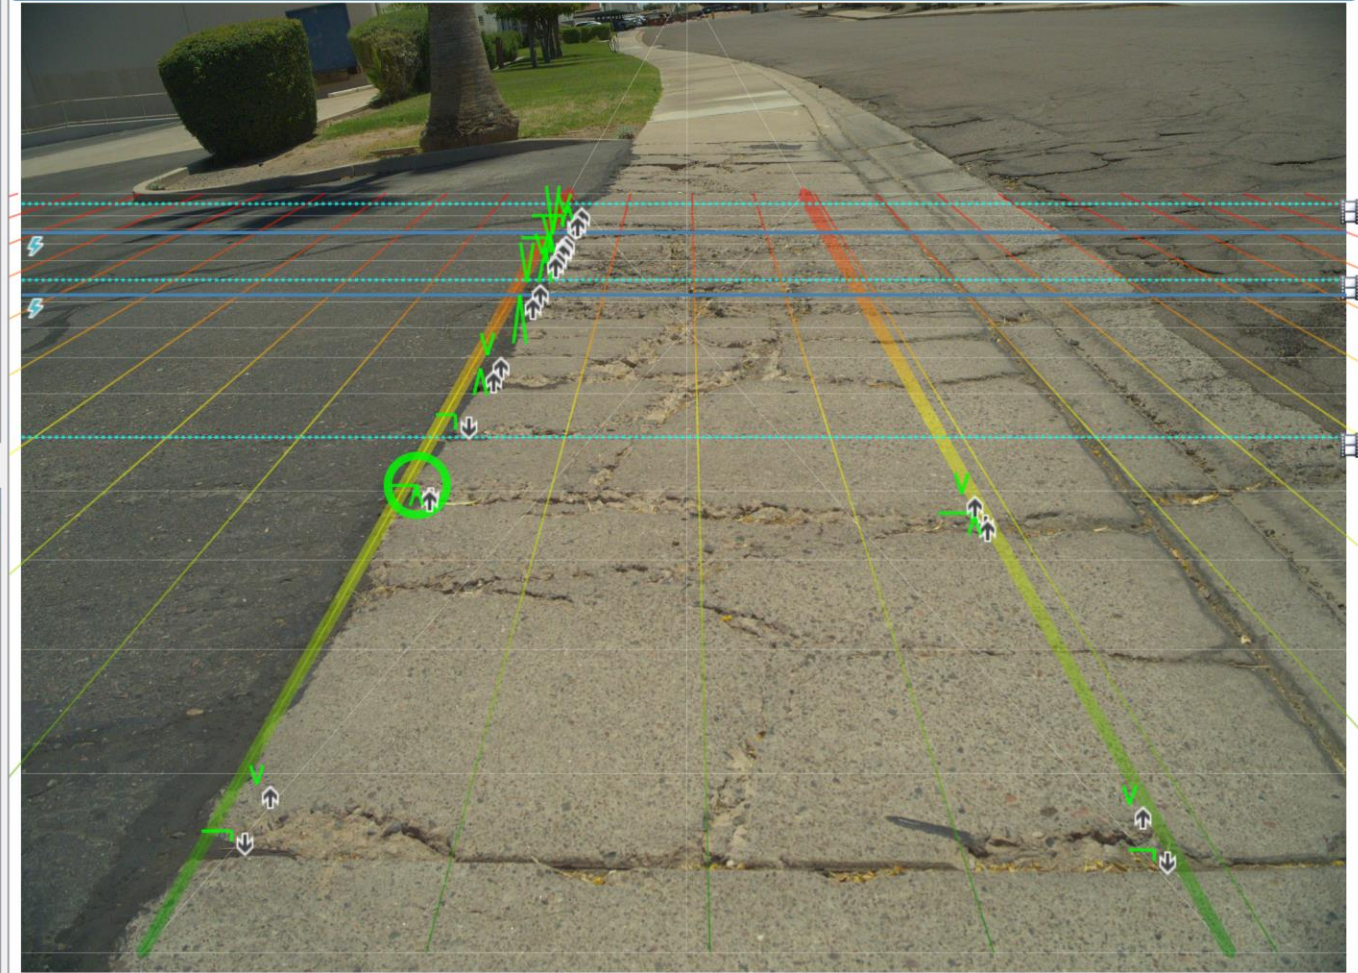
# Highly Distressed Section

Locat	Start [m]	End	Lengt [mm]	Depth	Width	Heigh	Rise/Fall Angle [°]	Distre	Sever	Items
<input type="checkbox"/>	L	270.102					-14.153	58.7			
<input checked="" type="checkbox"/>	L	270.113	270.182	69.816	16.423	40.473		64.2			
<input type="checkbox"/>	L	270.537	270.588	51.603	23.137	30.355		84.2			
<input type="checkbox"/>	L	270.899					-20.710	41.8

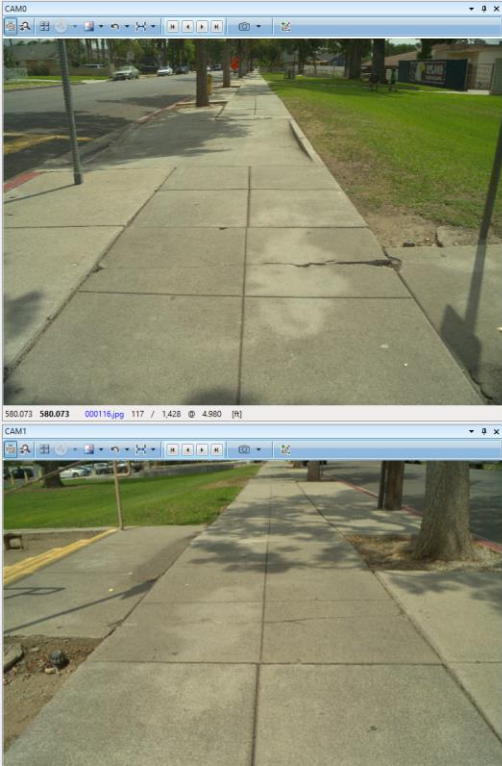
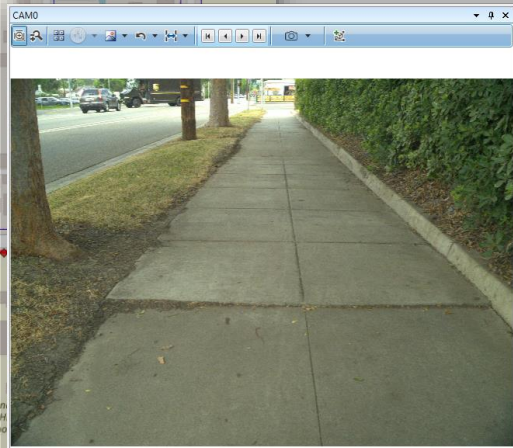
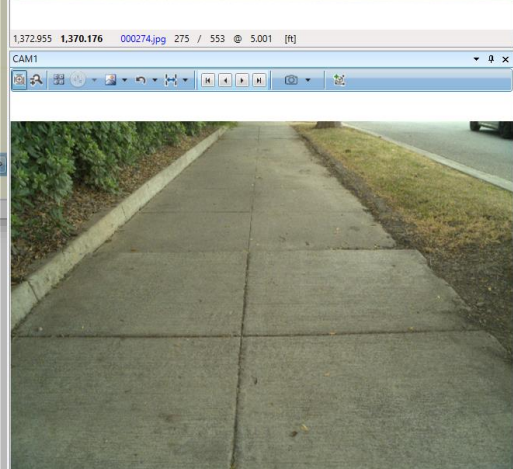
# Condition Rating

Vertical Displacements (Faults) - Automated

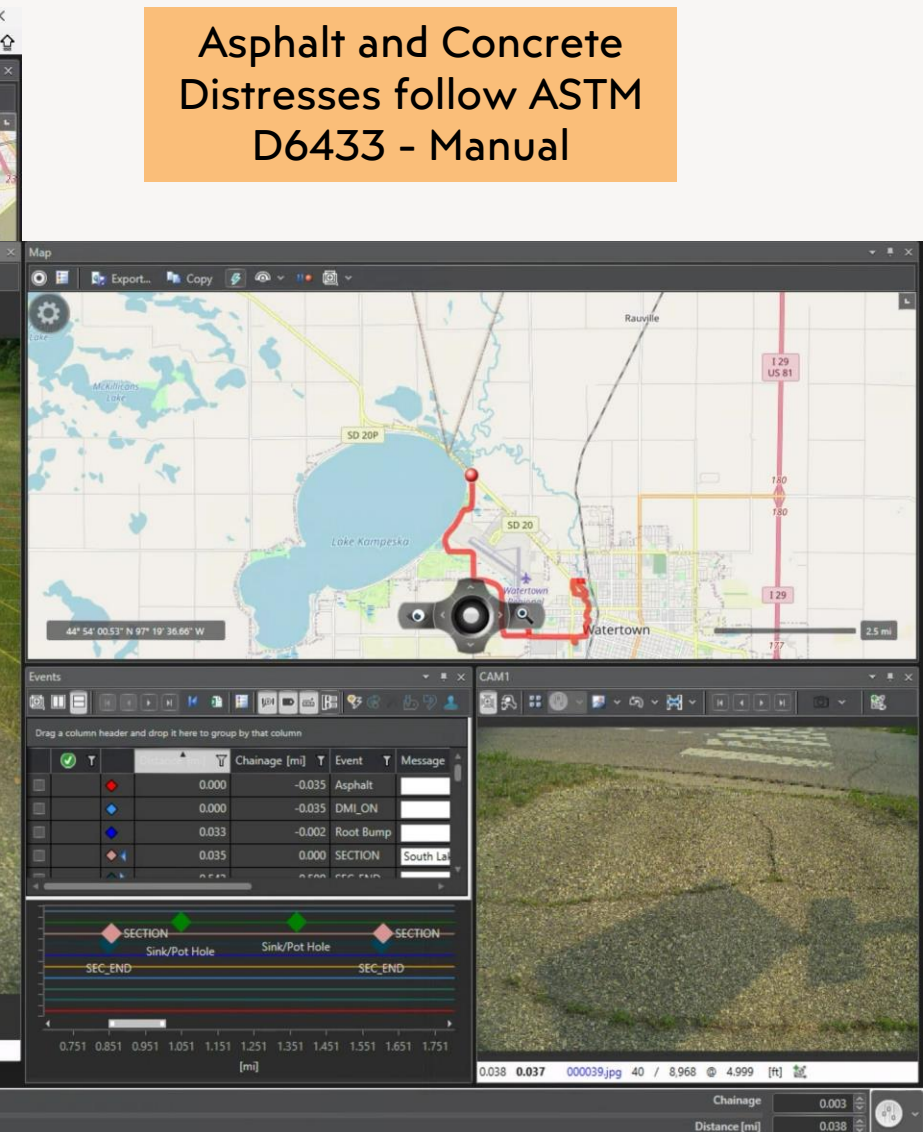
# Niagara Falls, Ontario, Canada

Asphalt and Concrete Distresses follow ASTM D6433 - Manual
